# Fatigue Failure of Alloy Grade P22 Hot Reheat Auxiliary Steam Pipe

<sup>1</sup>Materials Engineering & Testing Group, Tenaga Nasional Berhad Research Sdn. Bhd., 43000 Kajang, Selangor, Malaysia. <sup>2</sup>Plant Inspection Services, Tenaga Nasional Berhad Research Sdn. Bhd., 43000 Kajang, Selangor,

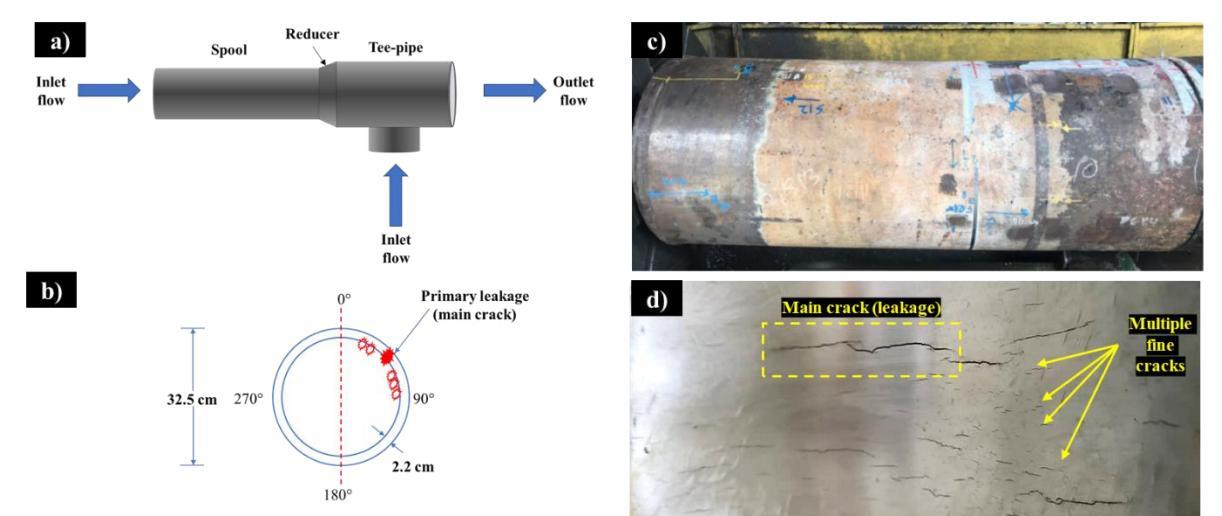
The material is a hot reheat auxiliary steam pipe that experienced leakage. The pipe has been operating for more than 130,000 equivalent operating hours (EOH) in a cyclic-load operating power plant. The operating temperature and the operating pressure were 540 °C and 49 bar, respectively. Figure 1 a) depicts the failure of the auxiliary pipe components, which include the pipe spool, reducer, and T-joint. The through-wall crack was identified in the spool pipe. The pipe was found to have bulging and cracks at the base metal area. Multiple linear indications were found at the base metal near the weldment of the spool and reducer. The main crack occurred in the spool over an arch length of 0° to 90°, as shown in Figure 1 b). Figure 1 c) shows the asreceived spool sample and Figure 1 d) shows the 0° to 180° side of the sectioned pipe with a circumferential main crack through (leakage) as well as multiple fine cracks on the internal surface.

**Figure 1.** a) General illustration of the spool, reducer and tee-pipe b) cross-sectional view of finding on spool c) as-received spool and d) 0° to 180° side of the internal sectioned pipe with the presence of numerous circumferential cracks.

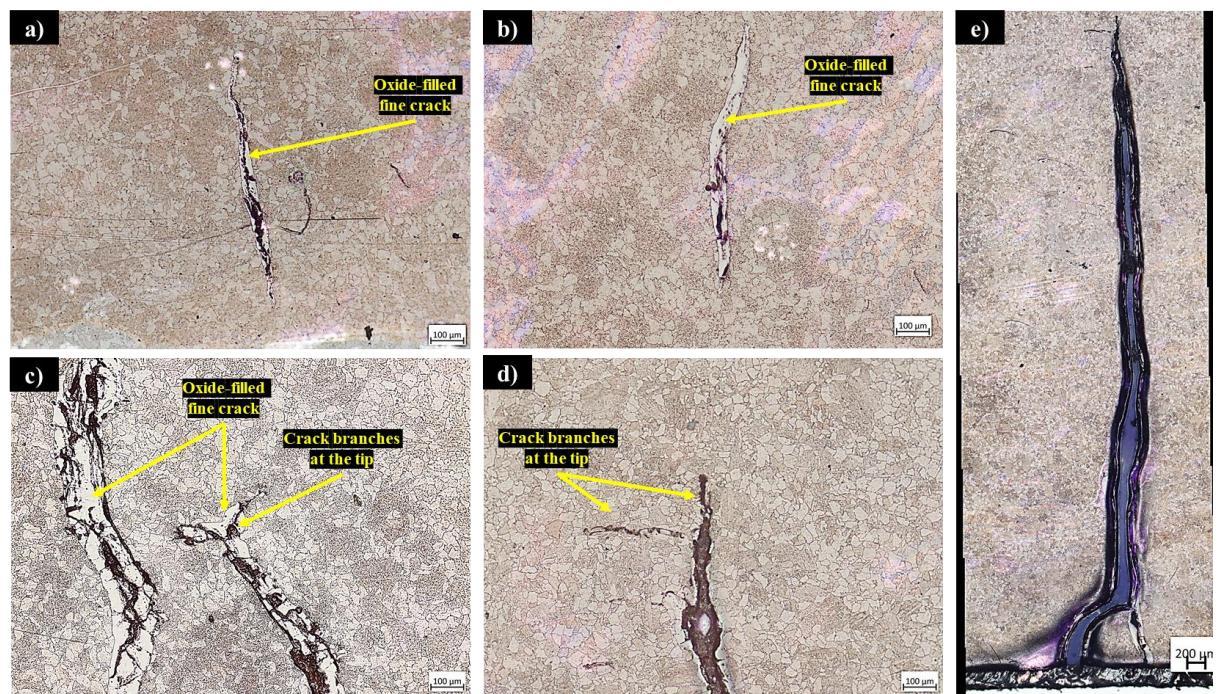
Figure 2 shows the microstructures of in-situ replication for P22 alloy etched with nital. All the microstructures show that the cracks occurred at the base metal. Figure 2 a) shows the unaffected area microstructure at the plane of 270° which consists of ferrite and bainite phases. Based on the thermal degradation classes as given by the Central Electricity Generating Board (CEGB), it shows that the microstructure of the as-received spool has degraded with bainite decomposition to class B, in which the carbides have spheroidized in a moderate manner, as compared to the new microstructure of tempered bainitic steel [9] which has well-defined bainite colonies. Figure 2 a) shows that the bainite phase has started to break up and the presence of carbides is observed in the base metal. Figure 2 b) and Figure 2 c) show fine cracks filled with oxide. Figure 2 c) and 2 d) show the split at the crack tips of the main crack and fine crack, respectively. Figure 2 e) shows a sharp, straight primary crack. The main characteristic of the fine cracks associate with propagation in a transgranular mode and oxide-filled. Such a crack appearance is associated with fatigue [10].

**Figure 2.** Microstructure of in-situ replication P22 alloy etched with nital revealing a) unaffected base metal at the plane of 270° (magnification at 100X) b) fine crack (magnification at 100X) c) fine crack (magnification at 100X) d) crack tip of the main crack (magnification at 100X) e) crack tip (magnification at 50X

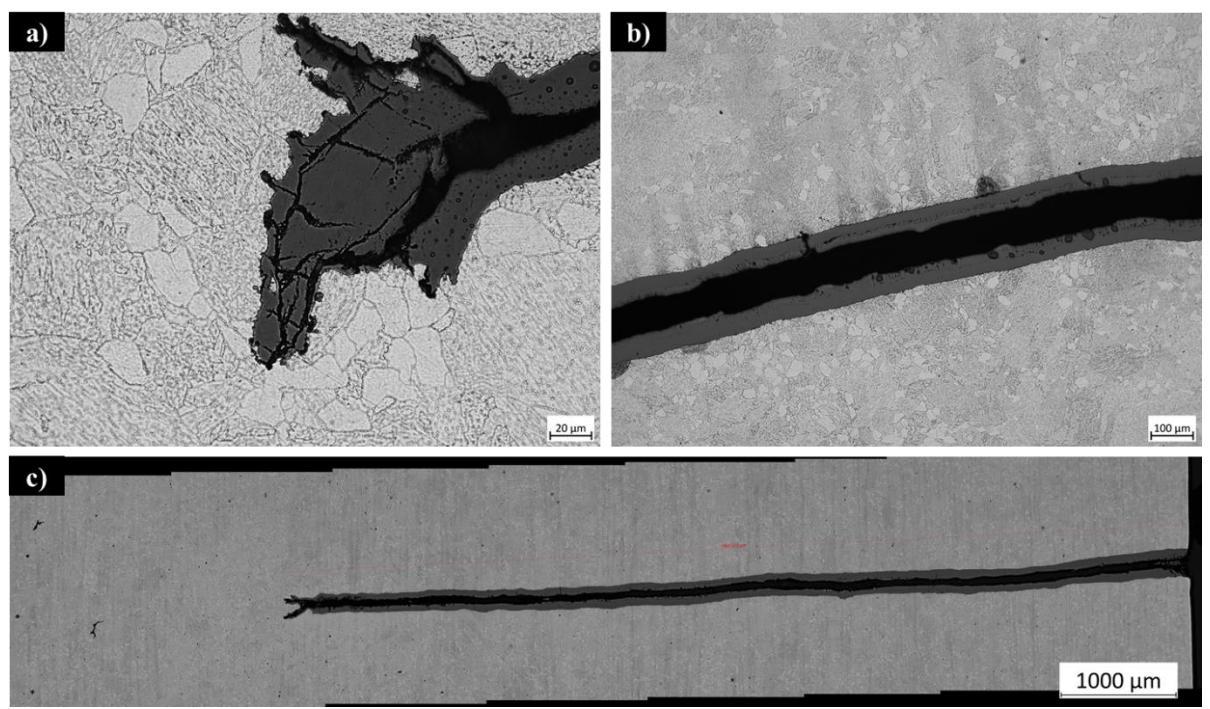
Figure 3 shows the microstructures of the mounted sample etched using nital. All the mounted samples show parallel cracks on the surface of the spool. The characteristics of the cracks are similar to those shown in replica films, which are multiple, parallel fine cracks that are propagated in transgranular mode and filled with oxide. Figure 3 a) shows the crack tip with small branches at the end, and Figure 3 b) shows the thick oxide layer in the crack. Most of the cracks are filled with oxides, which form at high temperatures and crack or rupture during operation cycles. The

Figure 3 c) shows the microstructure of the mounted transverse sample to show the crack depth. The crack was measured using ZEN Core 3.3. The crack shows a transgranular sharp crack with oxide filled and split ends. The deepest crack has already penetrated up to approximately 7.9 mm.

**Figure 3.** Microstructure of mounted P22 alloy etched with nital revealing a) oxide filled fine crack with branching tip (magnification at 500X) b) heavily oxidized cracking surface (magnification at 100X) c) crack depth (magnification at 50X)

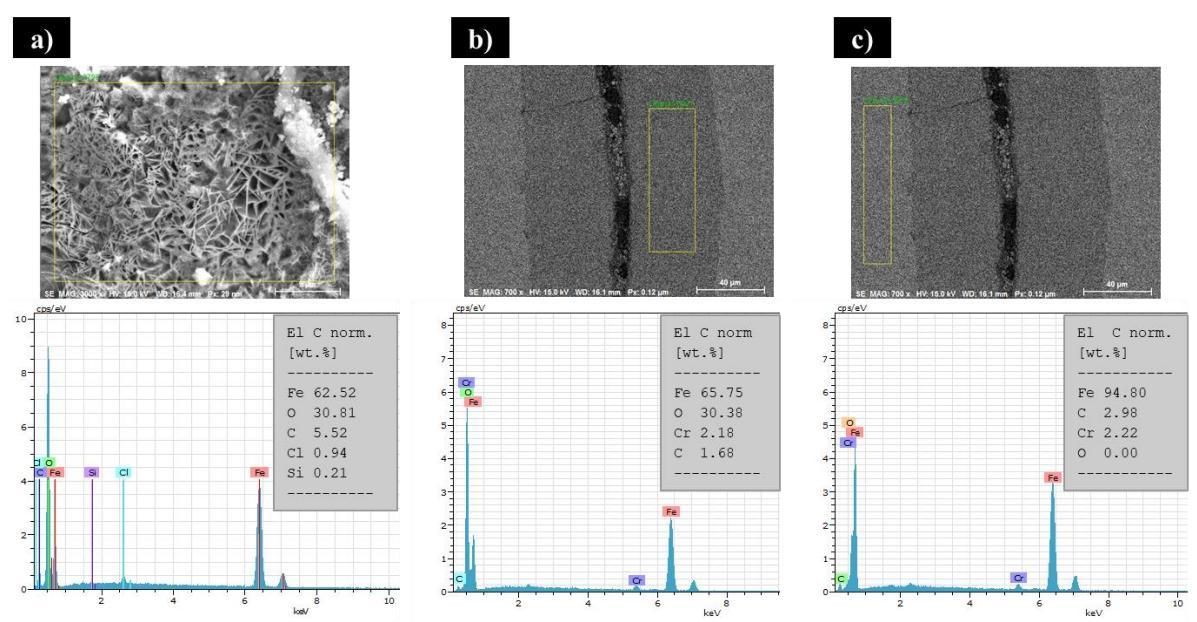
Figure 4 shows the EDX analysis of the a) oxide deposit, b) white phase at the crack, and c) base metal near the crack. Oxide deposits were collected at the internal surface using carbon tape. Figure 4 a) shows a high oxygen content (30.81%) in the deposits at the internal surface, which suggests the presence of oxide at the internal surface of the spool. Besides that, Figure 4 b) shows the EDX analysis of the unknown white phase. The result of oxygen content is quite high (similar to an oxide deposit), which suggests the white phase which is shown on the replica film is the formation of oxide in the base metal. Figure 4 c) shows the EDX analysis of the base metal near the crack. The result of oxygen is relatively low, which is consistent with the chemical composition result of P22 alloy.

Figure 4. Multipoint EDX analysis of a) deposit at the internal surface b) white phase c) base metal.

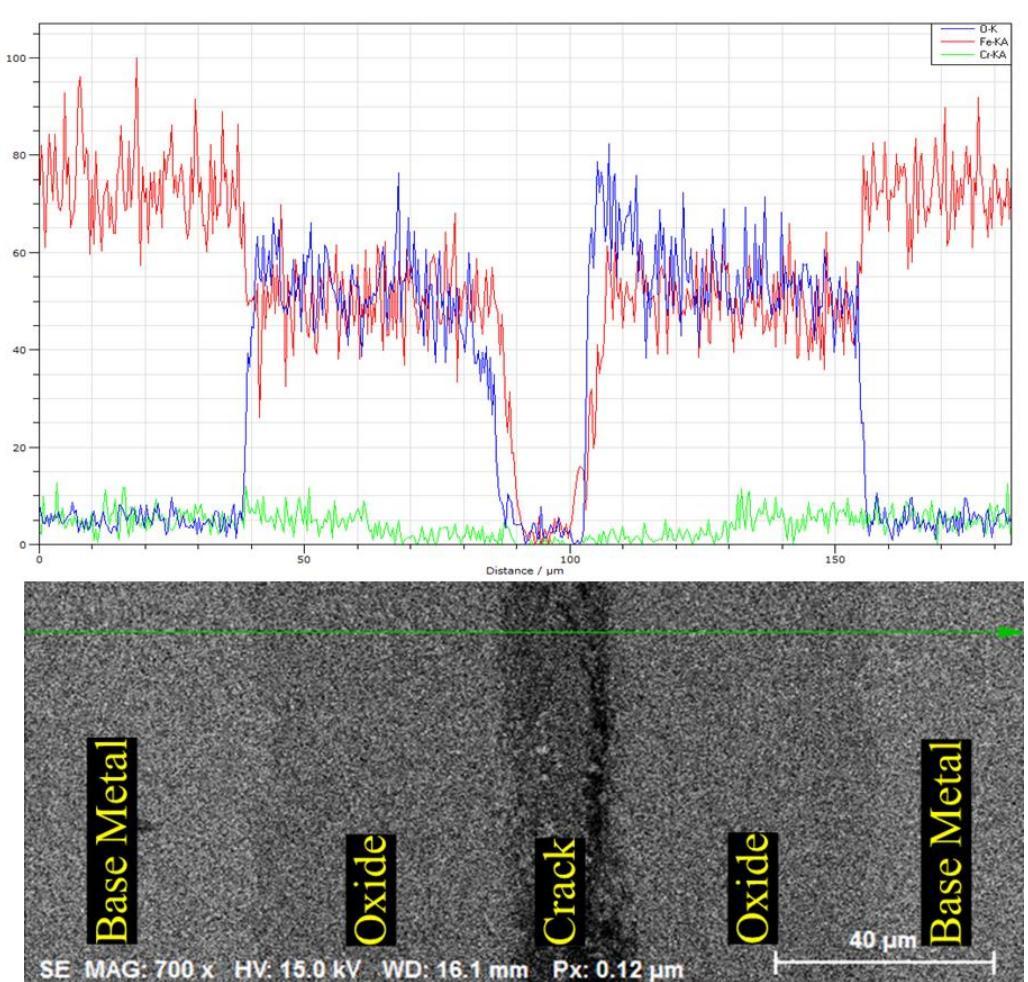
In addition, EDX analysis using the line profile scanning method was done to confirm the elemental composition of the crack as shown in Figure 5. The elements that were observed were oxygen (O), iron (Fe) and chromium (Cr). It shows that oxygen content rises rapidly at the unknown phase, which clarifies the phases as oxide. It was revealed that the oxide layer is mostly composed of magnetite ( $Me_3O_4$ ), when Me stands for metal such as Mo, Cr and Fe [5]. No apparent corrosive elements and no significant corrosion pits were found.

Figure 5. EDX profile scanning analysis relative to the region shown in the SEM.

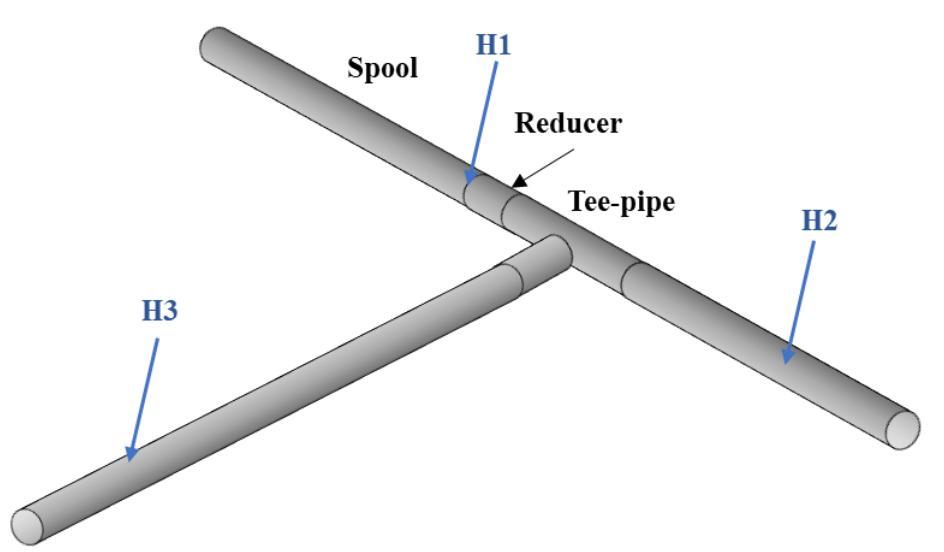
Additional information on pipe hanger inspection was obtained to identify the possible root cause of failure. It was reported that there are three hangers, which are H1 (constant hanger), H2 (rigid support) and H3 (variable hanger) in the neighbourhood of the pipe leakage as illustrated in Figure 6.

Figure 6. General illustration of nearby hanger location at hot reheat auxiliary pipe.

The inspection shows that H2 and H3 were still within the allowable range. H1, however, was reported in bottom over-scaled condition. A pipe hanger that is bottom over-scaled acts like a rigid hanger because it is unable to accommodate the pipe's thermal movement. The movement is constrained, and the pipe may experience increased stress as a result [12]. This suggests that the hanger is overloaded at that particular location where the hanger's suspended beam was found deformed. The malfunctioning pipe hanger could cause load transfer to adjacent piping sections [12] and introduce high-stress locations.

Besides, it was observed that some pipe snubbers of Hot Reheat Pipe (HRP) that connected close to auxiliary pipes showed signs of hydraulic fluid leakage and fluid indicator show low level or below minimum level or exhausted oil. As the snubbers hydraulic fluid was exhausted, it will not be functioning correctly. This condition is aggravated when air or dirt enter the snubber's valve. The snubber is used to protect the piping system from shock/transient load. When the snubber is not functioning correctly, it could not resist and protect the piping system from transient (as snubber freely slides; thus, it does not counteract the shock forces) [12]. Furthermore, broken pipe support strut ends, dislodged snubber pins and dislodged snubber ends were found on the HRP line show the sign of pipe snubbers have started to become malfunction. Based on the pipe hanger and support condition, it shows that the crack is likely attributed to the excessive cyclic stress on the piping system [12].
