Methods of Fractography Analysis Applicable to Understand the Solid-State Lighting Chip Crack Origin

OSRAM Opto Semiconductors (MY) Sdn. Bhd.

ABSTRACT

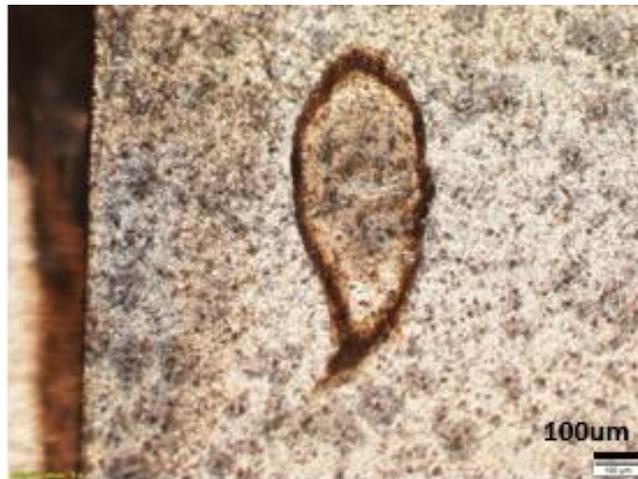
Figure 3. An optical representation of chemical damage on metallization if chemical residual not wholly removed.

The sample cleaning and preservation after decapsulation is significant to avoid chemical or mechanical damages. Figure 3 shows the image from a high power microscope of common chemical damage that has resulted in incomplete removal or dilution of the etchant residual. After chemical etching, a sample is cleaned by a reducing agent (such as ethanol, propanol or acetone) in an ultrasonic bath before dried in 55°C oven. When working with the lifted die, tweezer cannot be used while handling the die in order to avoid further crack artefact. As an alternative to tweezer, a soft tip suction is recommended.

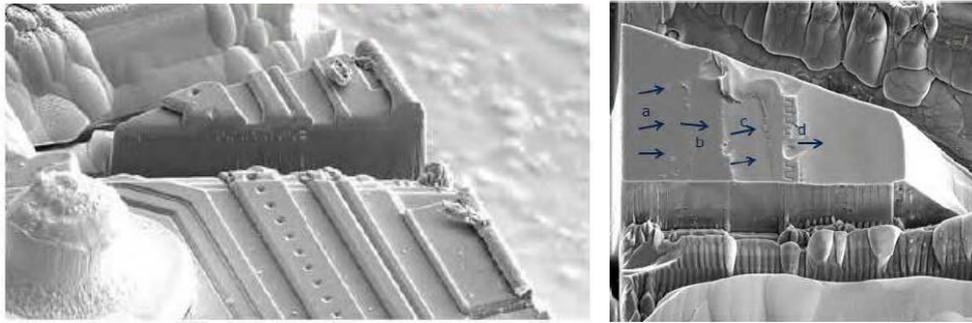
Figure 5. A cheesecake-like isolated island creates by the focus-ion beam (FIB). It reprinted with permission from [9] and not according to the scale for protecting proprietary information.

When chip crack further away from edges, there is an innovative method of using micro-sectioning which was shared by FK in 2013 [9] in order to expose the crack fragment. Figure 5 shows the formation of a micrograph of a cheesecake-like isolated island. Thereby, the crack fragment further away from edge could be either exposed by a short duration of ultrasonic agitation or exposed by welding to a micro-manipulator for lifting.
